## **2014 Operations, Maintenance, and Monitoring Report**

### **Perry Ridge Shore Protection**

State Project Number CS-24  
Priority Project List 14

June 2014  
Calcasieu Parish

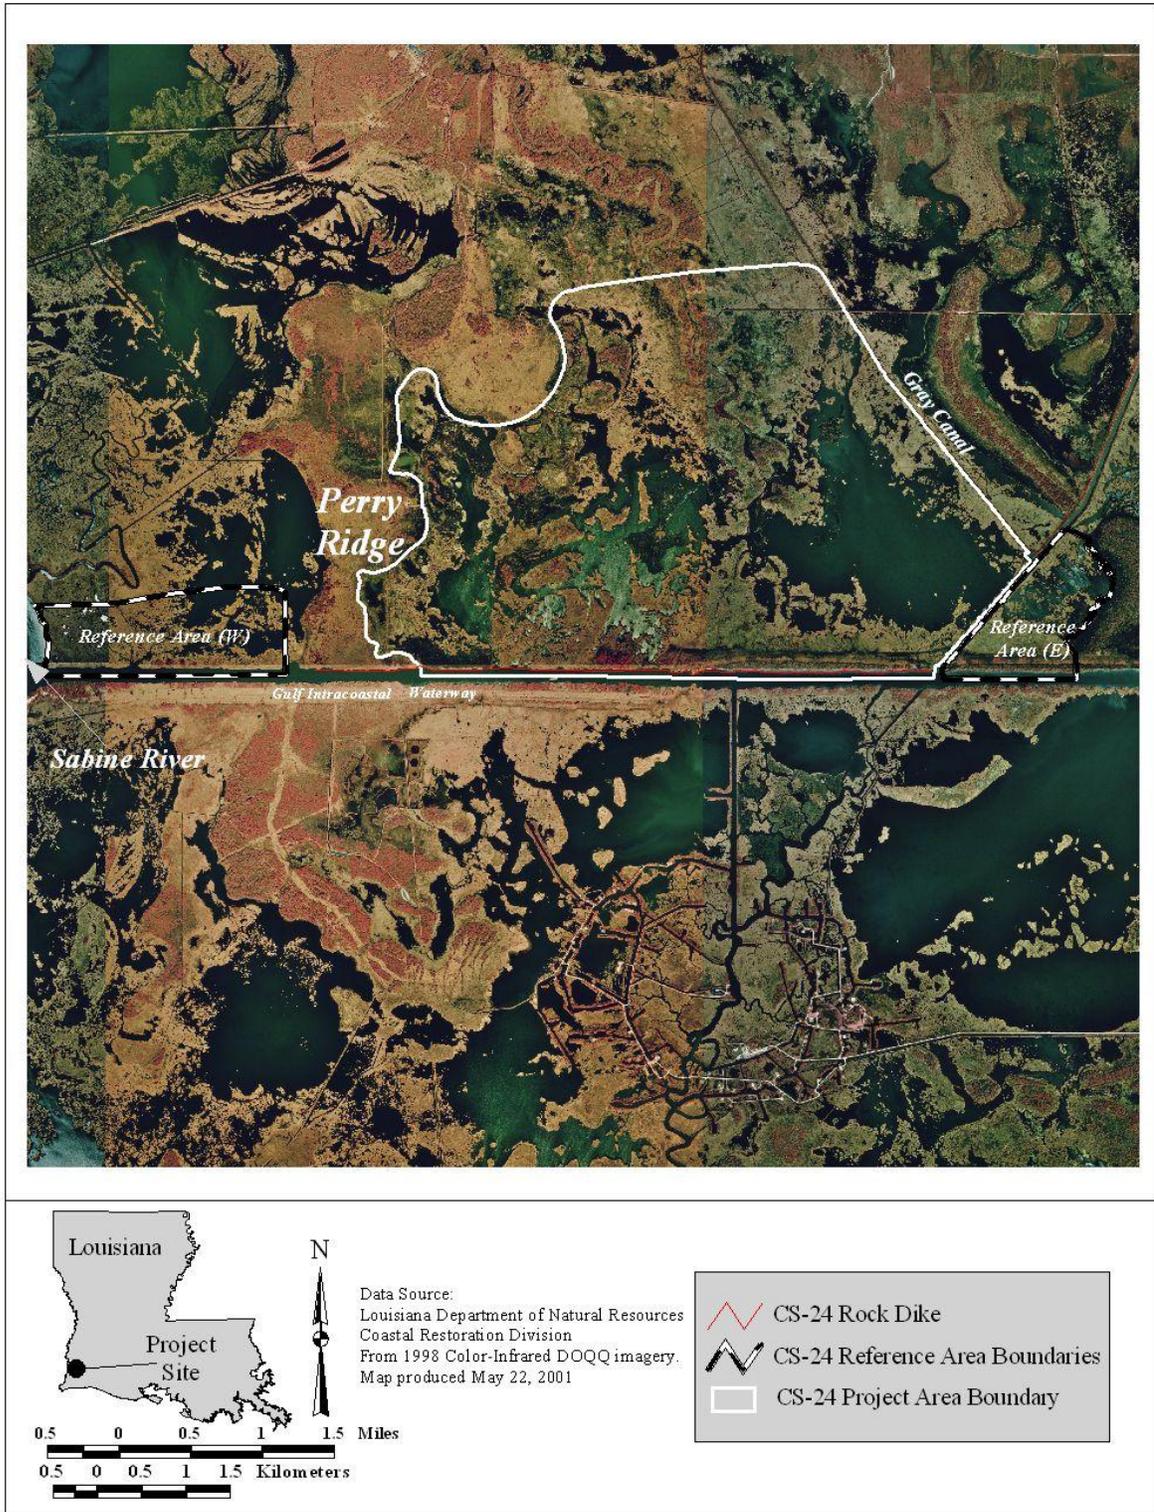
**Figure 1.** Perry Ridge Shore Protection (CS-24) project boundaries

Approximately 23,300 linear ft (7.1 km) of free-standing rock dike was constructed along the north bank of the GIWW from west of Perry Ridge to the Vinton Drainage Canal. Construction of the project was completed in February 1999.

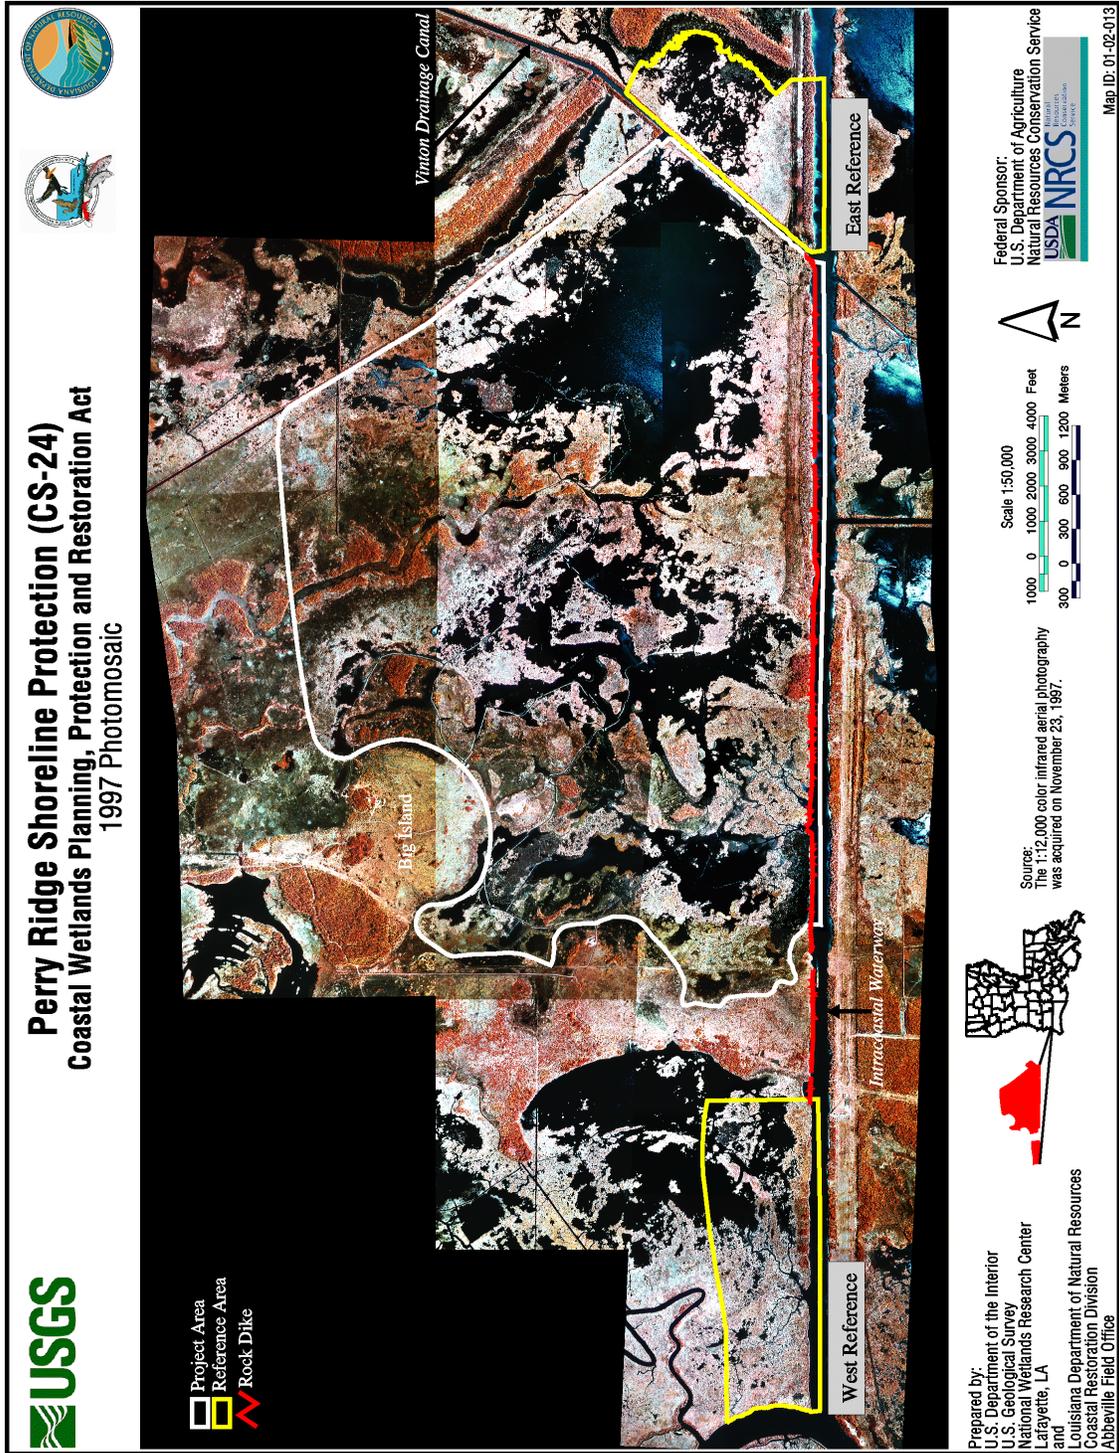
Pre-construction photography, flown on November 23, 1997, indicated that the project area was 60.4% land and 39.6% water (Figures 2 and 3). Aerial photography flown on November 17, 2001 documented 65.4% land and 34.6% water in the project area, indicating a land gain

**Figure 2.** Photomosaic of the Perry Ridge Shore Protection (CS-24) project and reference areas from aerial photography flown November 23, 1997

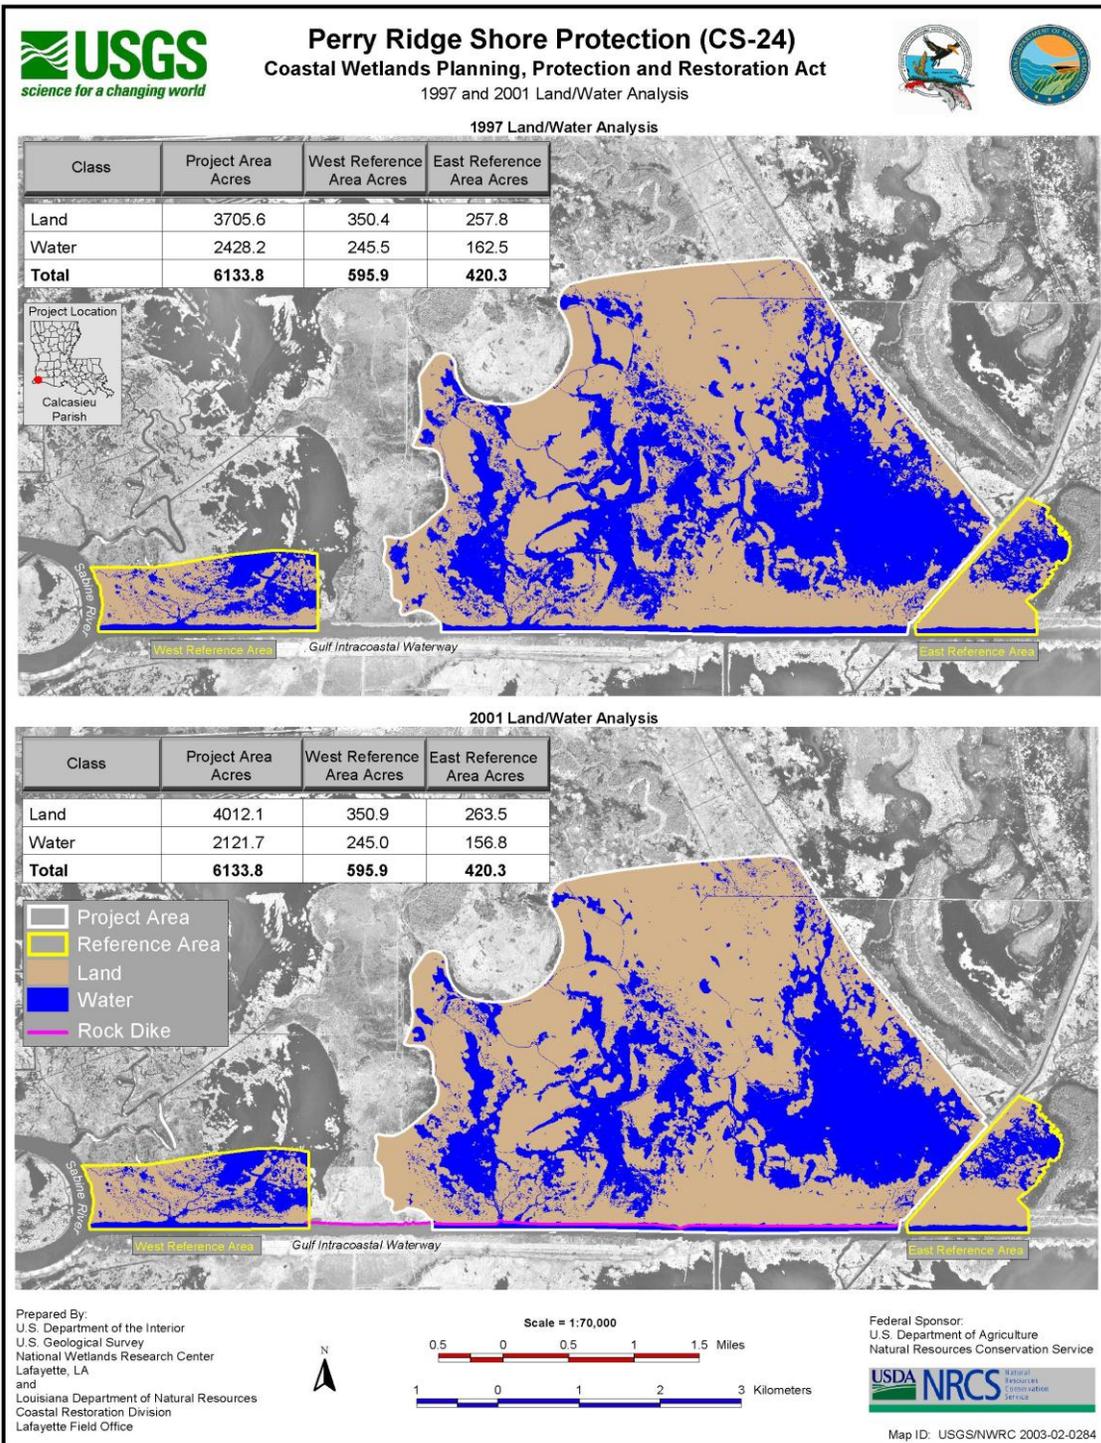
of 5% or 306.5 ac (124.0 ha). The higher land to water ratio indicates expansion of the interior marsh behind the protected shoreline. In areas without shoreline protection, the western reference area remained 58.8% land and 41.2% water, and the eastern reference area made a slight gain from 61.4% land and 38.6% water in 1997 to 62.7% land and 37.3% in 2001.

**Figure 3.** Pre- and Post-construction land/water analysis of the Perry Ridge Shore Protection (CS-24) project.

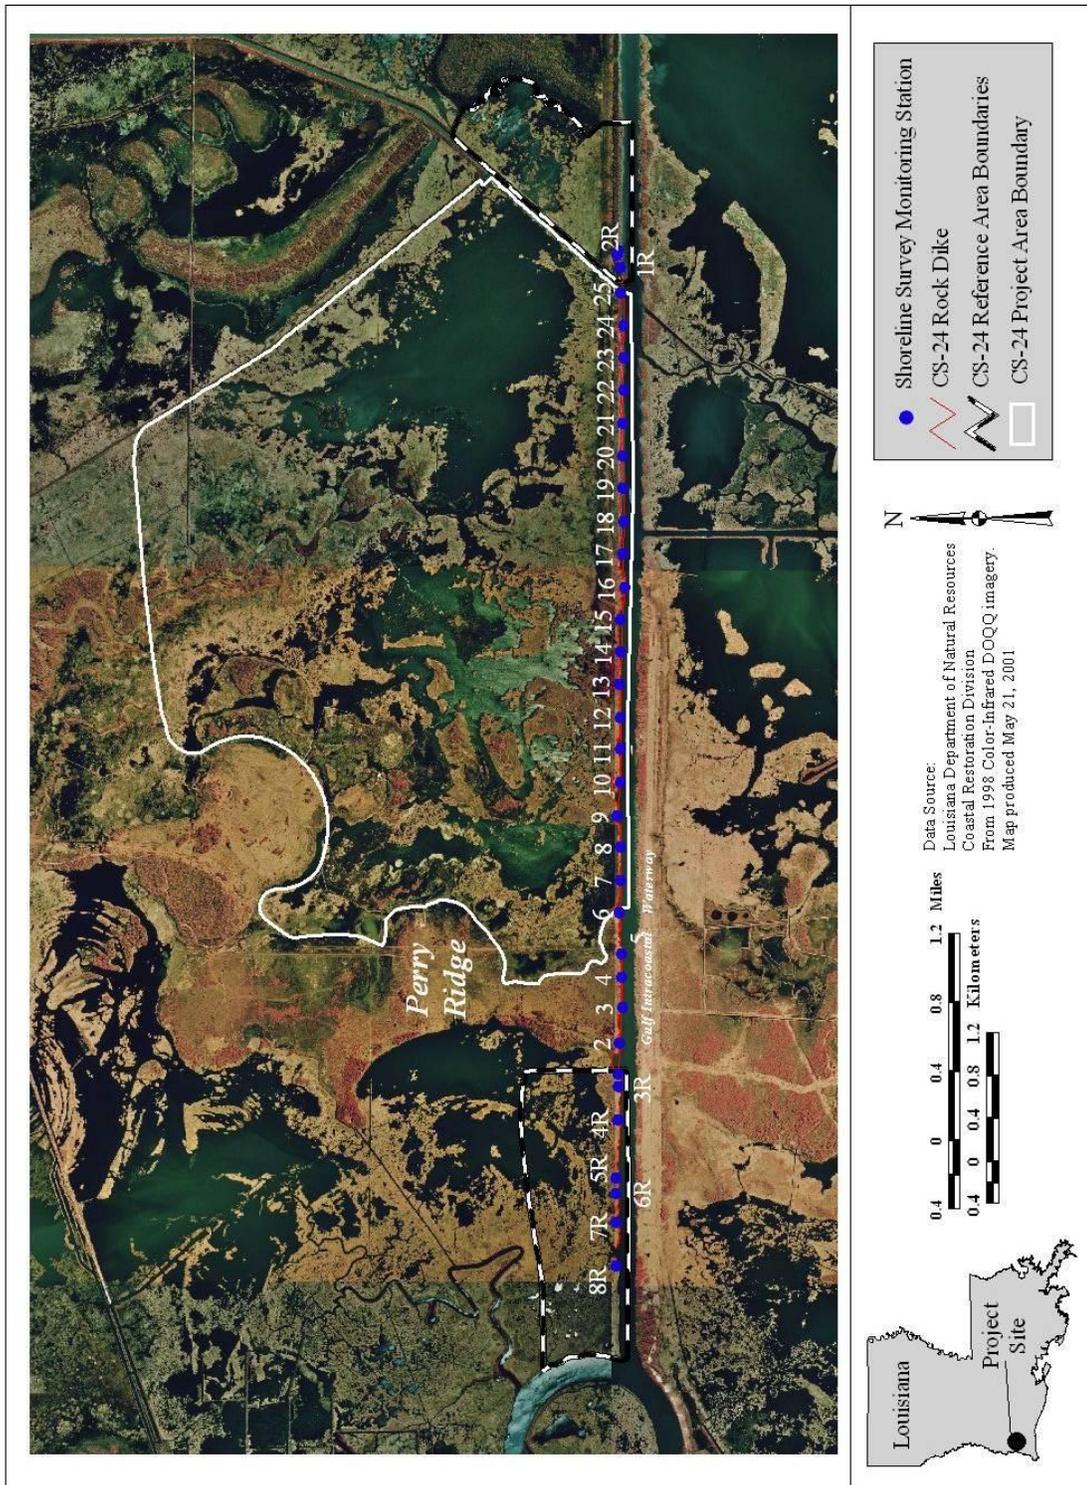
To document changes in shoreline position along the GIWW, shoreline markers were placed at 12 points along the vegetated marsh edge adjacent to the rock breakwater. Twelve transects were measured and differentiated by shoreline type in the project and reference areas (minimum of 3 but not to exceed 1 per 1,000 ft [305 m]). On each transect, a PVC pole was installed to mark the vegetated edge of the bank (VEB), and a post was installed at the end point in the marsh or on the spoil bank to establish a hub for use in relocating each transect. Shoreline position relative to the shoreline markers along the transects was documented at the same time of the year, once as-built in 1999, and post-construction in 2002, 2004, 2007, 2010 and 2013, and will be documented in 2016.

**Figure 4.** Perry Ridge Shore Protection (CS-24) shoreline marker station locations.

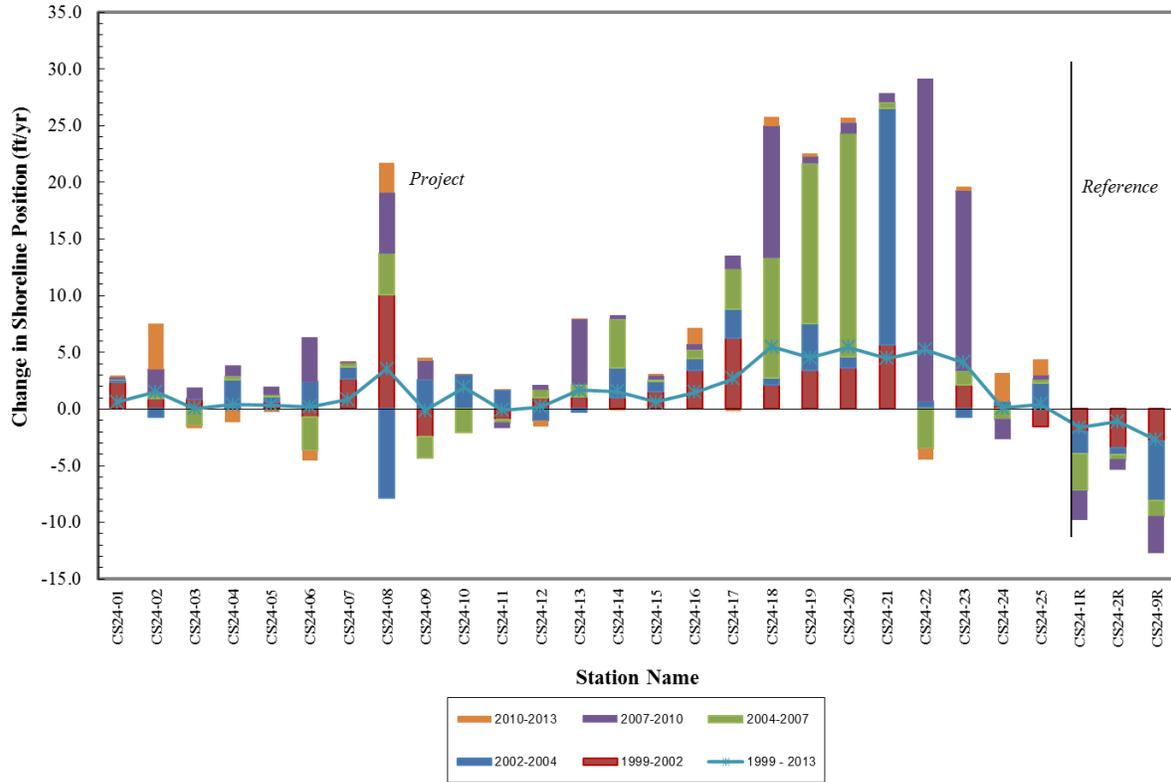
Average shoreline rates across all surveys in the project and reference areas are presented in Table 1. The 2013 data indicate an average gain of 0.41 ft/yr in the project area and an average loss of -0.1 ft/yr within the reference area. Along the shoreline in the project area, 17 of 25 monitoring stations are either prograding or had no change since the 2010 survey. However, at 12 of the project stations, substantial vertical accretion has taken place allowing vegetation to colonize up to the rock breakwater. It is important to note that the shoreline advance observed, as well as any future advance, will be restricted to the area behind the rock breakwater. This explains the lower gain rate in the project compared to previous surveys.

**Figure 5.** Shoreline position change (ft/yr) from direct measurements in the Perry Ridge (CS-24) project area from 1999-2013.

The 2013 shoreline survey indicates the project has continued to be effective at preventing shoreline erosion. The average rate of gain over all 25 project stations was 0.41 ft/yr while the shoreline in the reference area stations continued to retreat at a rate of -0.1 ft/yr. The vegetated shoreline is now bordering the rock dike at nearly half of the monitoring stations. The next shoreline marker survey is scheduled for the summer of 2016. The structural components of the Perry Ridge Shoreline Protection Project are in good condition and functioning as designed.

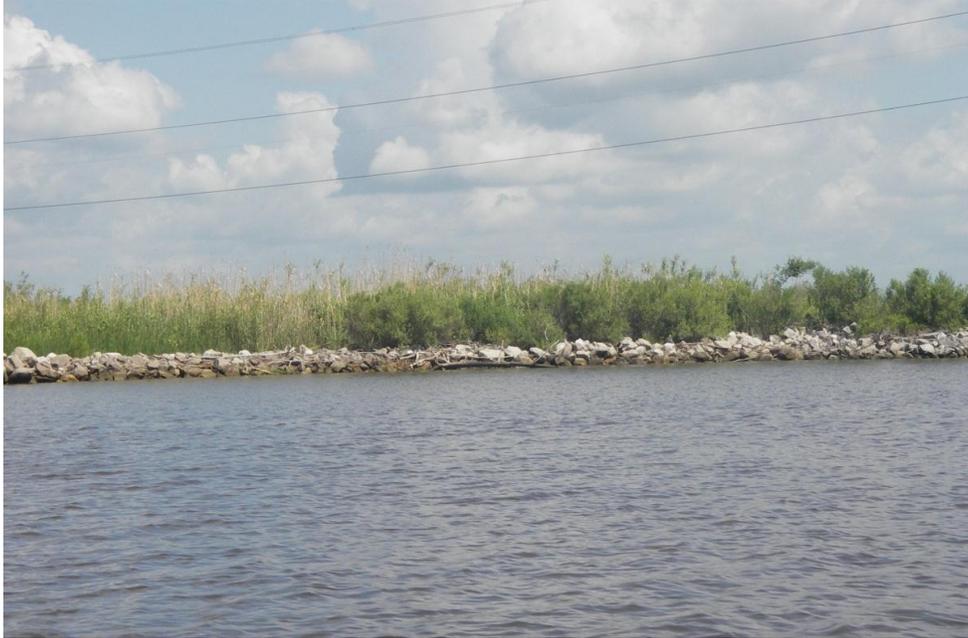
The dike is in good condition with a few low areas below constructed elevation. One 50 foot gap was noted where the dike was disturbed by a barge. Visible signs of accretion are

**Photo No.1, Typical Rock Dike**

Item	Condition	Physical Damage	Corrosion	Photo #	Observations and Remarks
Steel Bulkhead / Caps	N/A				
Steel Grating	N/A				
Stop Logs	N/A				
Hardware	N/A				
Timber Piles	N/A				
Timber Wales	N/A				
Galv. Pile Caps	N/A				
Cables	N/A				
Signage / Supports	N/A				
Rip Rap (fill) (foreshore dike)	Good			1-2	Rock Dike in good condition. A few low areas below original construction elevation. One 50 foot gap in dike possibly due to a barge nosing into rock. Accretion occurring behind rock dike.
Earthen Embankment	N/A

occurring behind the rock dike. No maintenance is recommended at this time. (Photos: Appendix A, Photo 1-2)

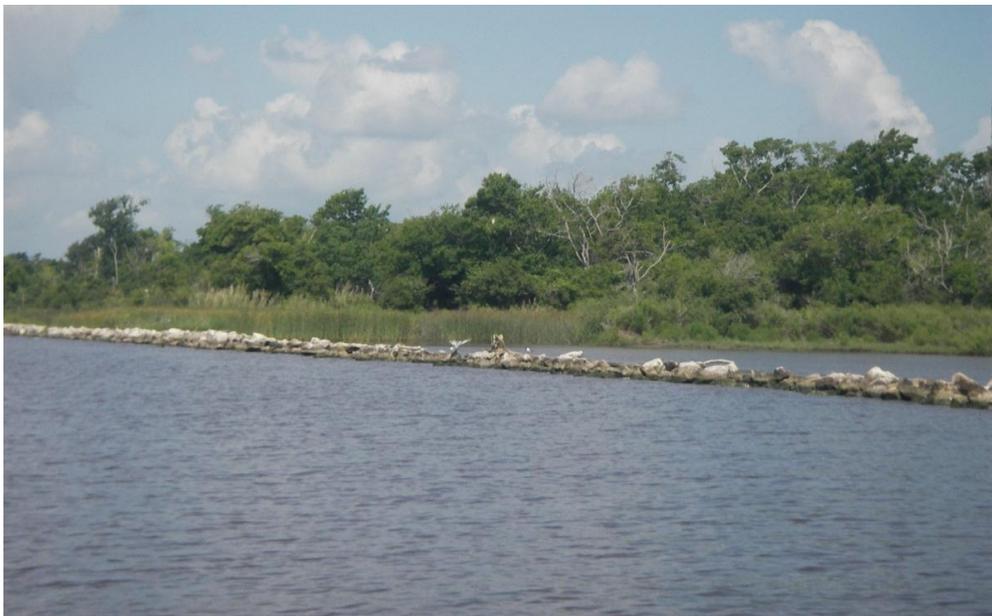
**Photo No.2, Accretion behind Rock Dike**
